**CENTRAL TEXAS
HOME INSPECTIONS
4404 RIVER OAKS DRIVE
BROWNWOOD, TX 76801
PHONE: (325) 998-4663**

PROPERTY INSPECTION REPORT

Concerning: 123 Main Brownwood Report # 9999
(Address or Other Identification of Inspected Property)

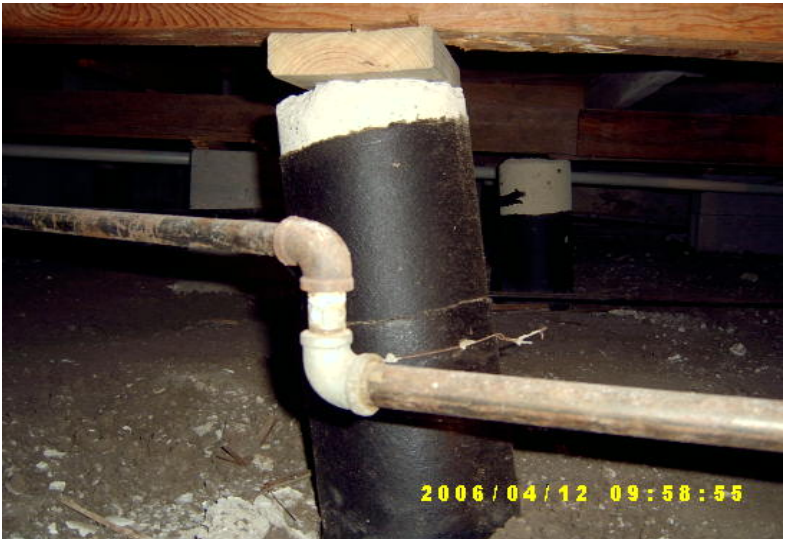
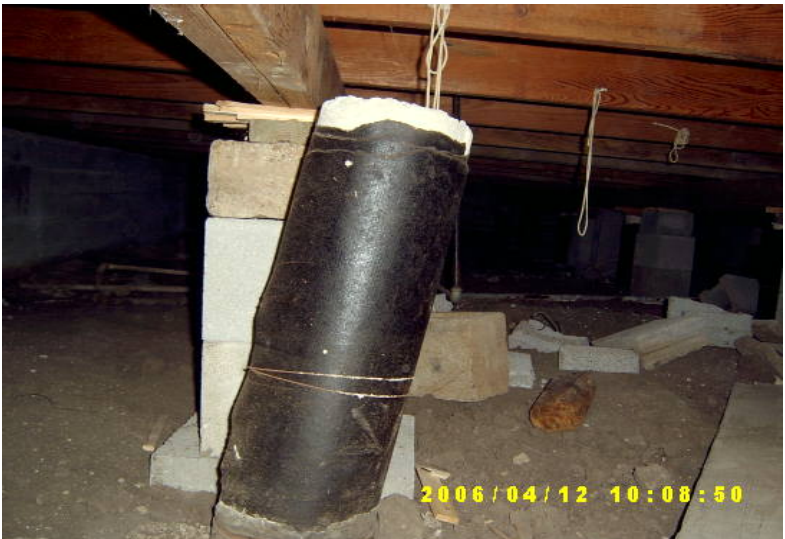
The house was originally supported by approx. 8 inch diameter concrete piers and still is to some extent. Several of the concrete piers, however, are leaning significantly or no longer providing support. This indicates that there had been quite a bit of movement.

Due to the severe movement of the piers and the movement that has occurred to the roof framing (discussed below), I recommend that a structural engineer or foundation specialist further evaluate the foundation.

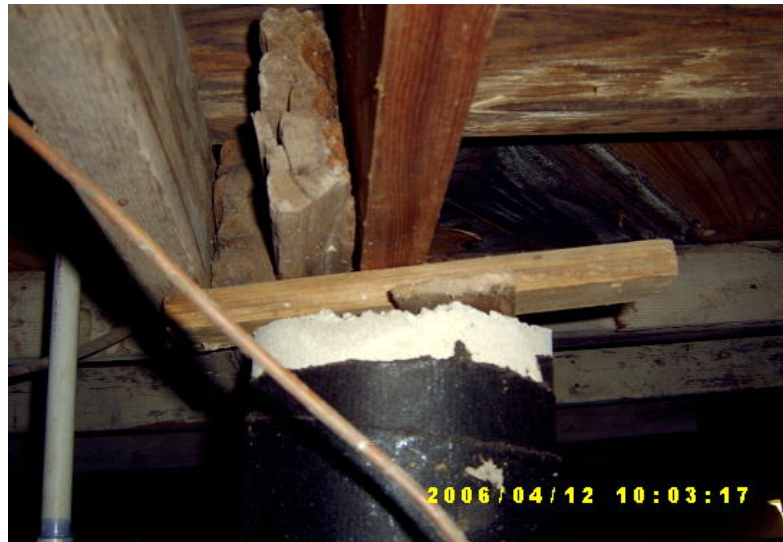
There have been quite a few cinder block piers added to help to support the home. I observed one of these that did not have a footer underneath.

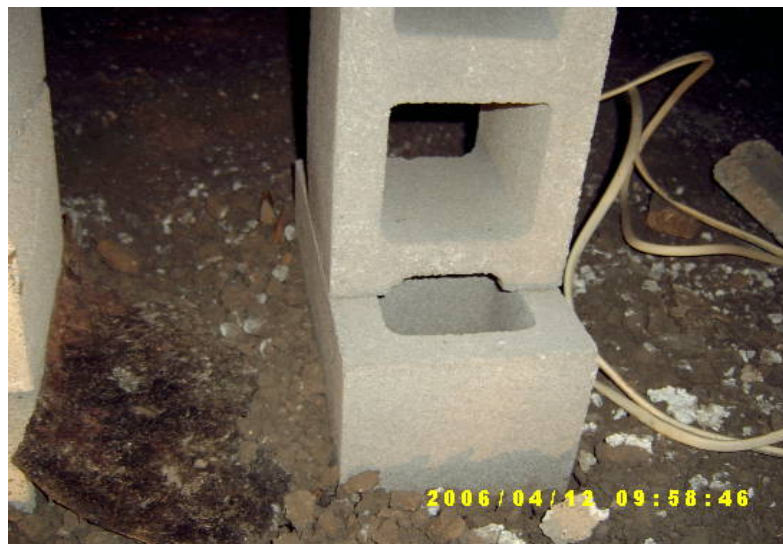
The ground is damp under the area of the hall bathroom. I did not see any leaks, however. There is insufficient ventilation in the crawlspace.

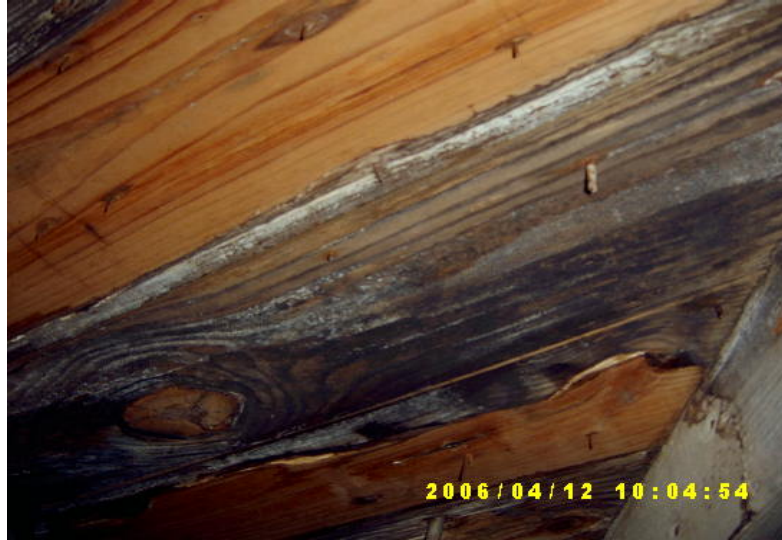
There is some minor rot on some of the subfloor.

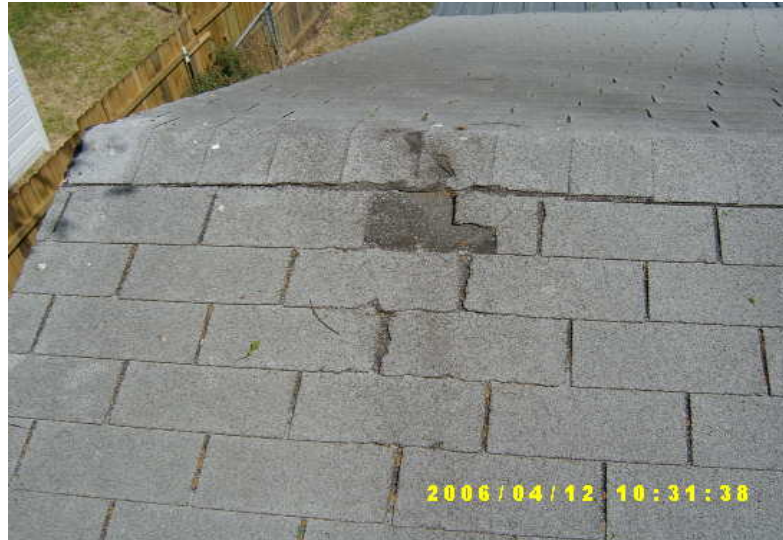
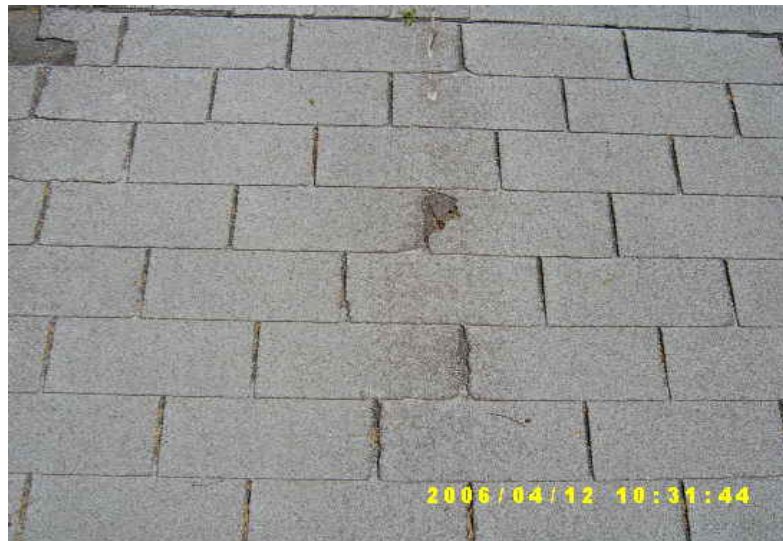
There is some tree damage on the west end of the roof.

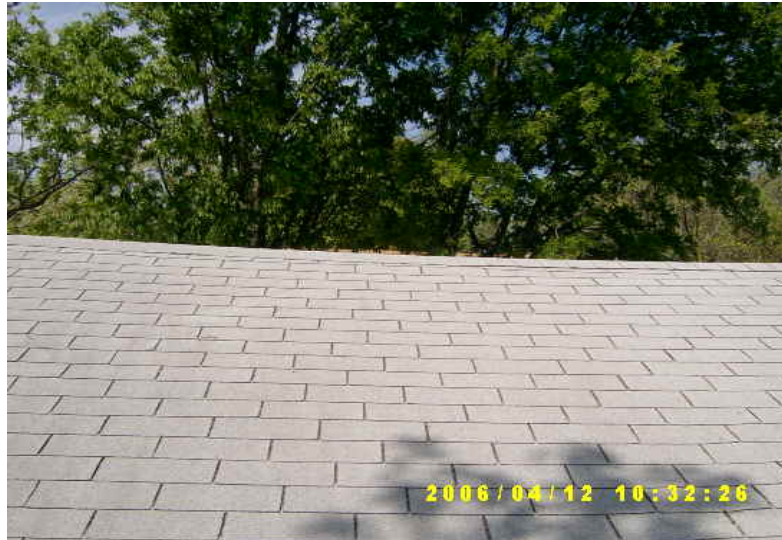
The ridge of the roof over what used to be the garage has some sag in it.

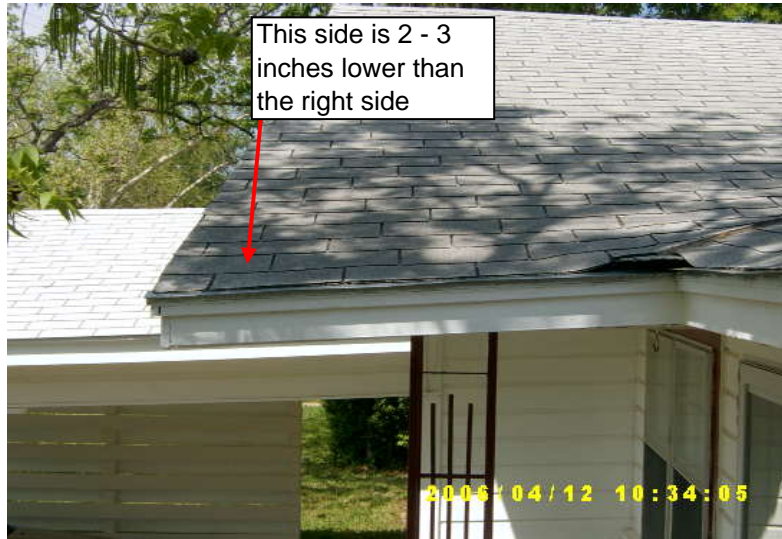
The roof over the front porch is sagging.

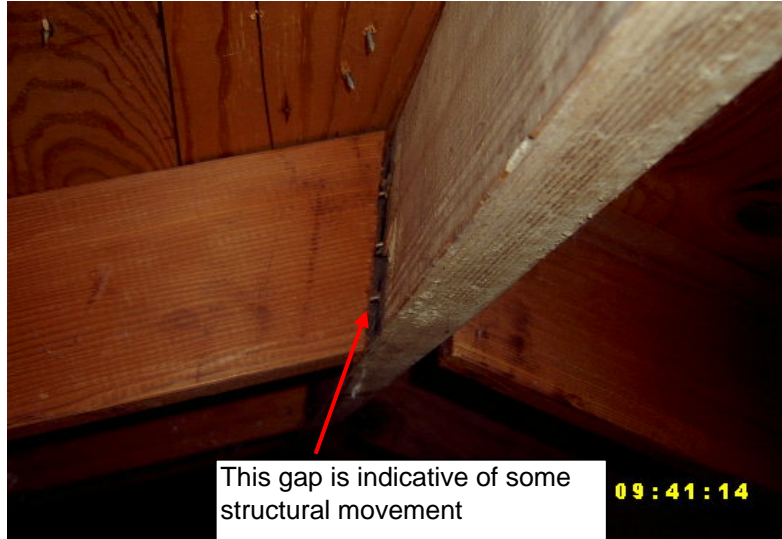
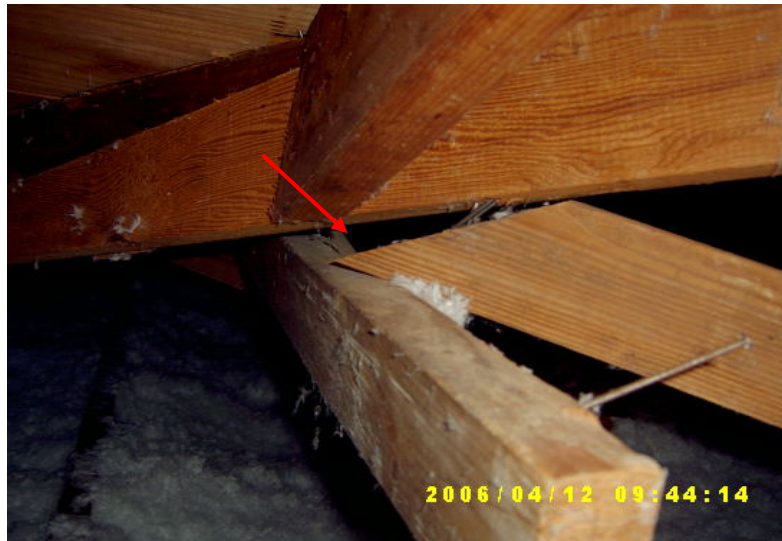
In the area where the front of the garage used to be, there has been some minor movement in the attic as indicated by some minor separation between some of the framing members.

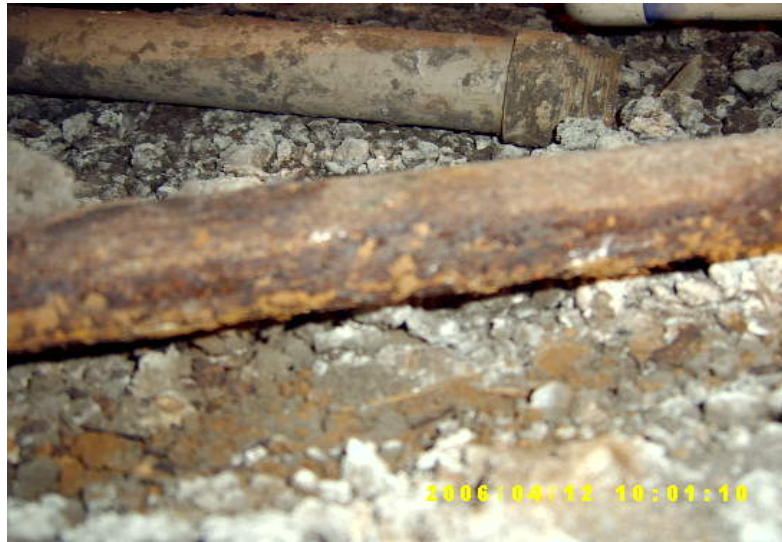
E. Gas Lines
Comments:
 There are galvanized pipes under the home that appear to be gas lines. Some of these are laying on the ground and are very corroded.
